Lubrication System Audit
Report Paper Machine *

SKF

SKF Lubrication Services Division

August ****

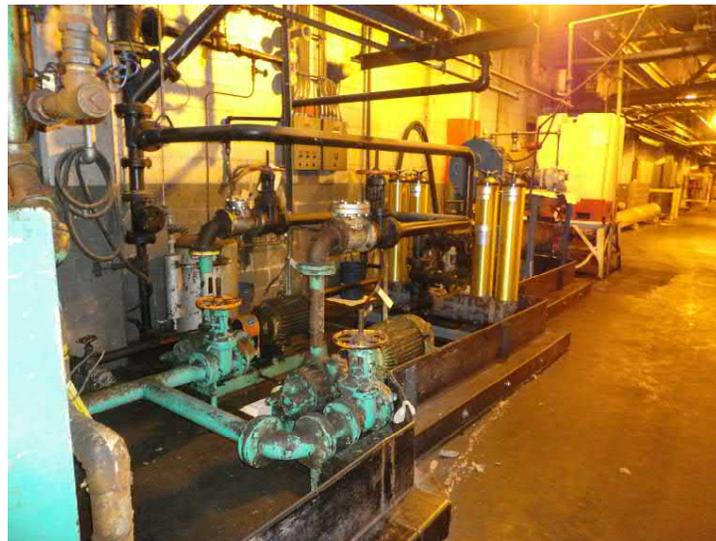
The oil pumps, filters, reservoir and other components of the main lube system are located in the basement on the drive side of the machine. It is closer to the wet end, not in the middle of the machine as most are. See the next picture showing part of this system.

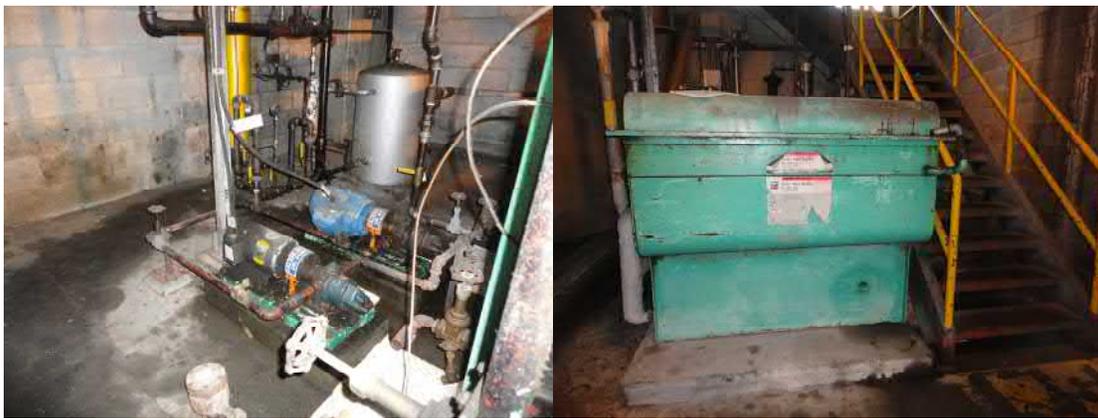
After the fifth dryer section there is a Calander Stack one King and one Queen Roll and two calander rolls. Next is a three dryer cylinder After Dryer section. Following that is a second Calander Stack with a King and Queen Roll and four more calander rolls. The bearings in this part of the machine are lubricated by a second oil system. This one is much smaller than the one lubricating the five main dryer sections. This oil circulation unit is in the machine basement, drive side not far from the after dryer sections. See the following two pictures. The picture on the left shows the systems oil pump and oil filter while the one on the right shows the systems oil reservoir.

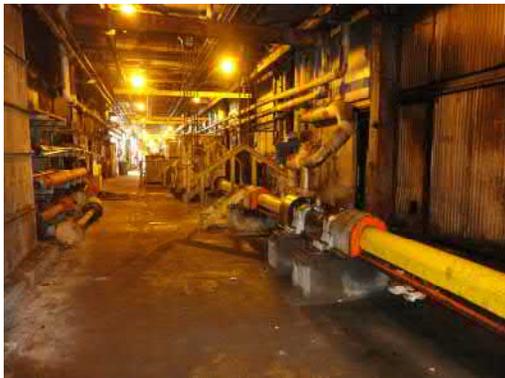
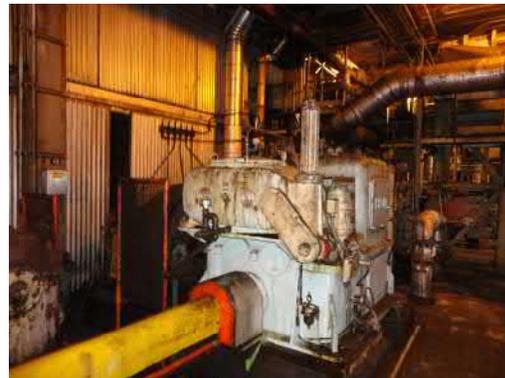
While we were not asked to audit the lube system for the machine's differential drives we felt some basic information about it needed to be included in this report. This machine's dryer sections are still driven by a line shaft and Beloit style differential drives. Please see the following two pictures. The one on the left is a shot down the line

shaft towards the steam turbine that drives it. The other is one of the eight differential drive gear boxes connected to the line shaft.

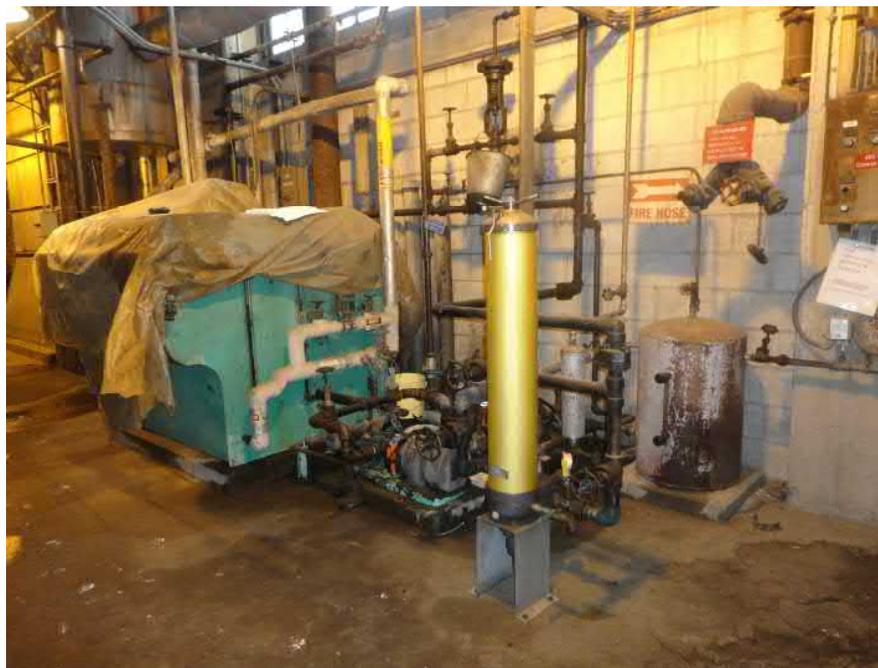
The gearboxes, transfer cases and PIV units are lubricated with oil from a third lube system also located in the machine basement. That is shown in the next picture.

In all, the eight differential drives, associated transfer cases and PIV units have a total of 60 lubrication points which are supplied oil by this oil system. All three oil circulation systems on this machine use ISO 220 oil.

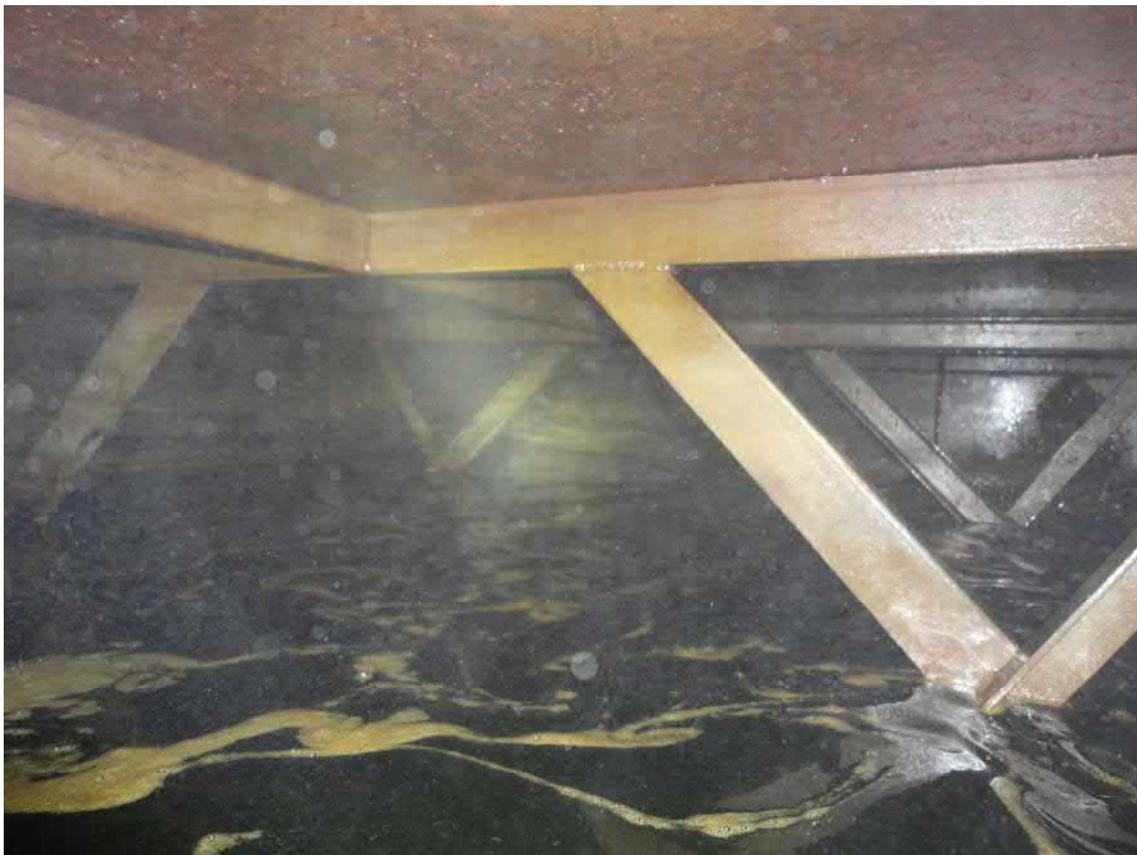
water and dirt that might be mixed in it before being pumped back to the paper machine. For instance, if a paper machine needed 100 gallons of oil per minute for all its bearings and gears, the oil reservoir would be designed to hold approximately 3000 gallons and have some excess room for air above the oil plus room for internal parts like baffles and heaters. This reservoir does not have any baffles to help with water and air separation. See the next picture. It only has some supporting steel braces and steam heating coils at the bottom.

At the current flow rates and pumping capacity the reservoir with the maximum of about 2,500 gallons of oil in it will provide approximately 27 minutes of retention which would be fairly good. However, if the

The present oil reservoir is large enough for the oil flow the machine gets today provided the level is kept up. However, the existing oil reservoir will not be large enough when oil flow rates are at their recommended levels. If this reservoir remains in use it should be retrofitted with new internal baffles to improve its ability to remove water and air.

This reservoir, if re-used, should be retrofitted with several low-watt density electric heaters, in stainless steel sleeves so any one heater could be removed for service without draining the oil from the reservoir. In most cases, we try to keep the watt density of electric heaters at or below 5 watts per square inch to avoid burning the oil. A new or rebuilt reservoir should have several heaters, maybe 8 or more in a reservoir this size. The length of the electric heaters can be almost as long as the reservoir is wide. That alone helps reduce the watt density.

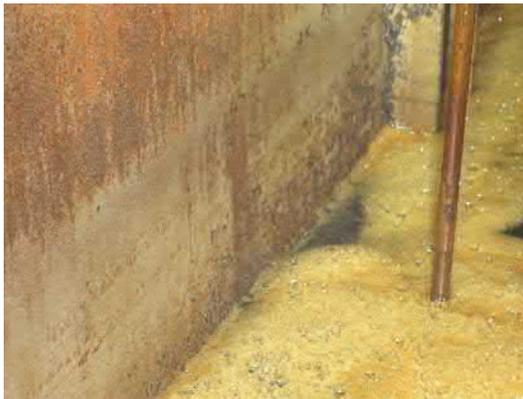
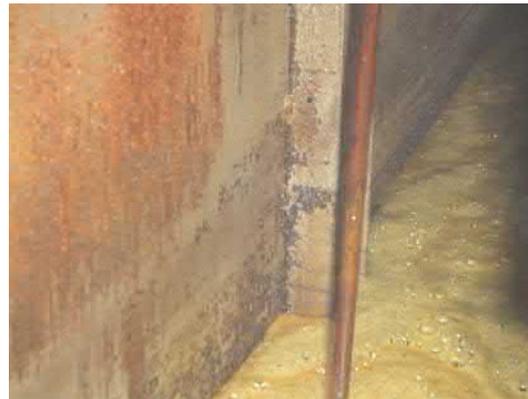
The two pictures below show some rusting on the inside of the walls of the reservoir and there were some similar signs on the underside of the reservoir's top. In these pictures one can see excess foaming on top of the oil indicating too much air is getting into the oil. We will comment on this in the section regarding pressure control. Also note the black material on the sides of the reservoir. We could not safely reach a sample but it appeared that it could have metal in it. Perhaps from the gear wear we heard about.

We did not see much condensation inside this reservoir during our inspection but we did see rusting. A new oil reservoir or an upgrade of this existing one should include a method of removing moisture laden air and replacing it with clean dry air. Large amounts of condensation can build up on the inside of the reservoir's top metal plate due to the difference between the oil temperature inside the reservoir and the air temperature outside it. The condensation then drips off the underside of the top plate and into the oil. It can amount to a

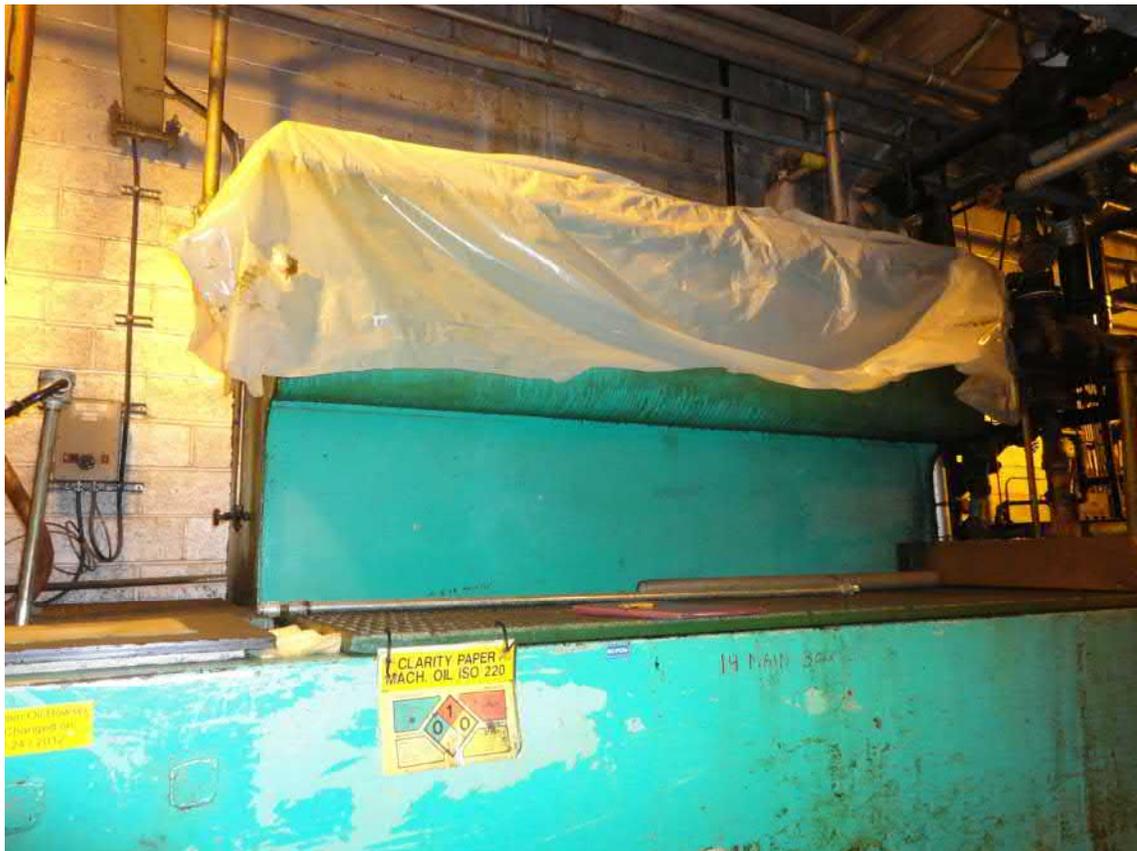
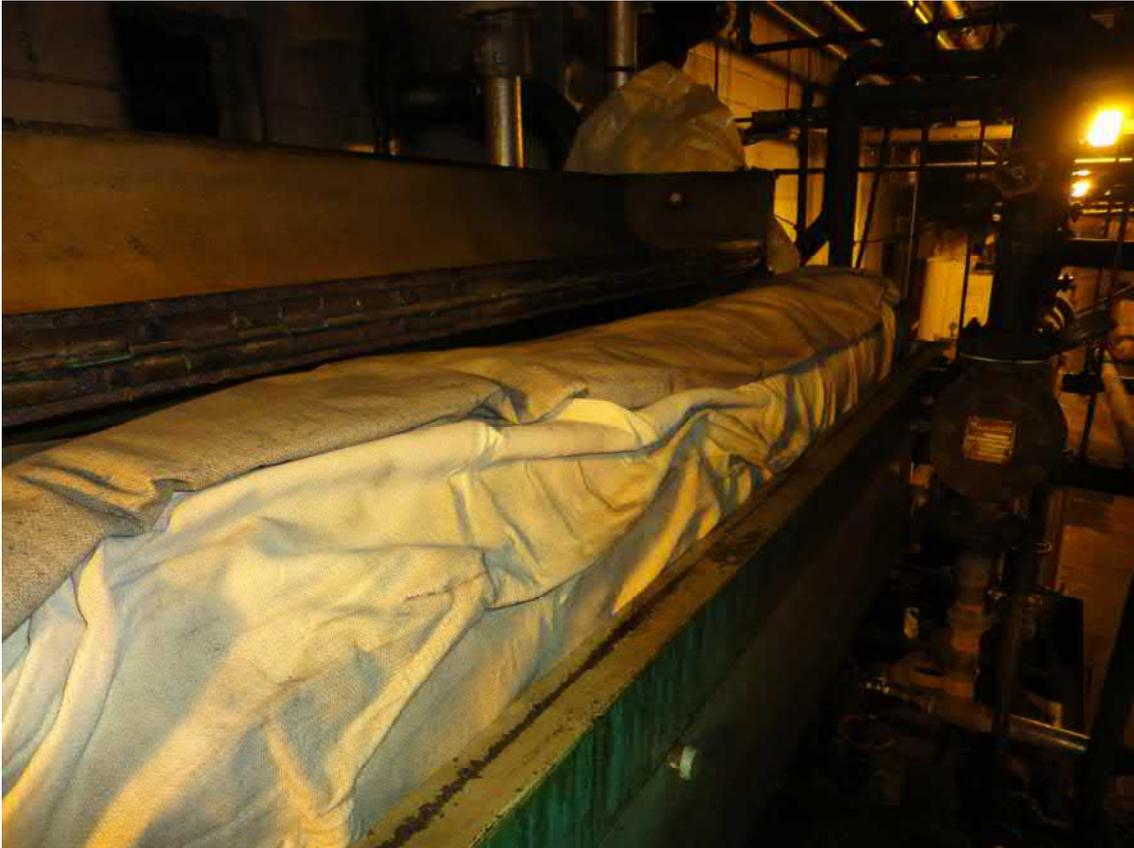
This system has a Beloit oil filter assembly on top of the main reservoir. This was part of the original equipment. The oil returns from the paper machine into this device that is called a roll filter assembly. The returning oil once had to pass through the filter blanket before it could drain into the main reservoir below. See the next picture. The roll filter assembly sets on top of the main reservoir

and now is mostly covered with plastic. Inside there is still a used filter blanket – see second picture. This should be removed if the mill is no longer going to use and maintain it. These devices filtered in the 40 to 50 micron range, taking out larger particles that might return in the oil from the paper machine. These were used before there were good filters that could be put into the pressure side of the system to filter before the bearings, not after.

If the mill does not plan to repair and maintain the filter blanket the whole assembly including the metal tank should be removed. This will make room for a second inspection cover in the tank top if this reservoir continues to be used. These filter assemblies are just another place for contaminants to enter the oil if they are not properly sealed and maintained.

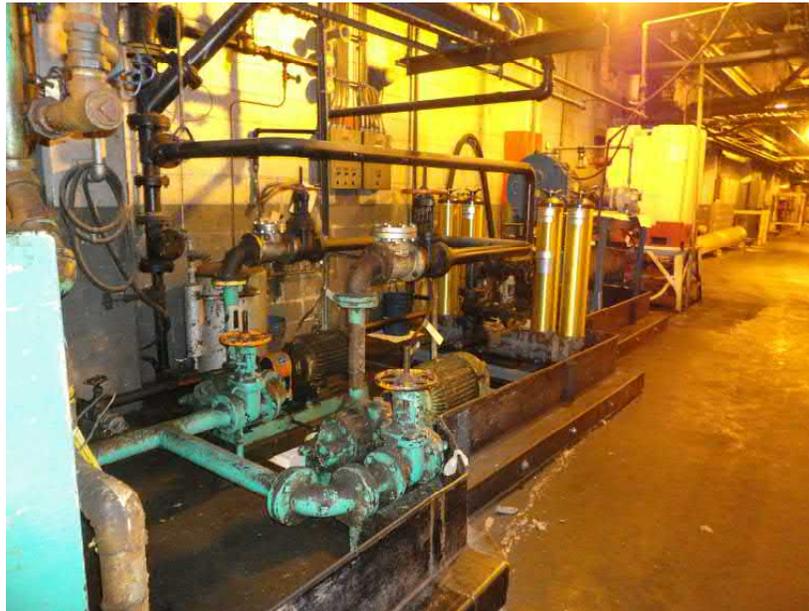
The **oil pumps** in this system are Roper 2F 75. They are driven by 10 HP **electric motors** turning 1170 rpm. The oil used in this system to lubricate all the points in the five dryer sections is Chevron Clarity PM ISO 220. At this speed the Roper pumps when in perfect condition pumping this oil at 140 degrees Fahrenheit will supply approximately

88 GPM oil. The arrangement around the two oil pumps can be seen in the next picture. Each has an internal safety relief valve. We could not determine what pressure they were set to relieve at but that pressure should be at least 150 PSI. We noted that these pumps do not have an external pressure relief or safety valve between the pump and first manual shutoff valve. That is a safety requirement by most standards to have the safety dumping back into the oil reservoir.

This system should have two safety relief valves installed. One for each pump. These should be piped to relieve oil back into the oil reservoir somewhere away from the pump suction. The dump line from the safety valves should include a flow sight glass with a flapper to indicate when oil is flowing or starts to flow through either valve. This is a good troubleshooting tool and helps when field setting relief pressures. Typically these valves would be set to crack at 150 PSI.

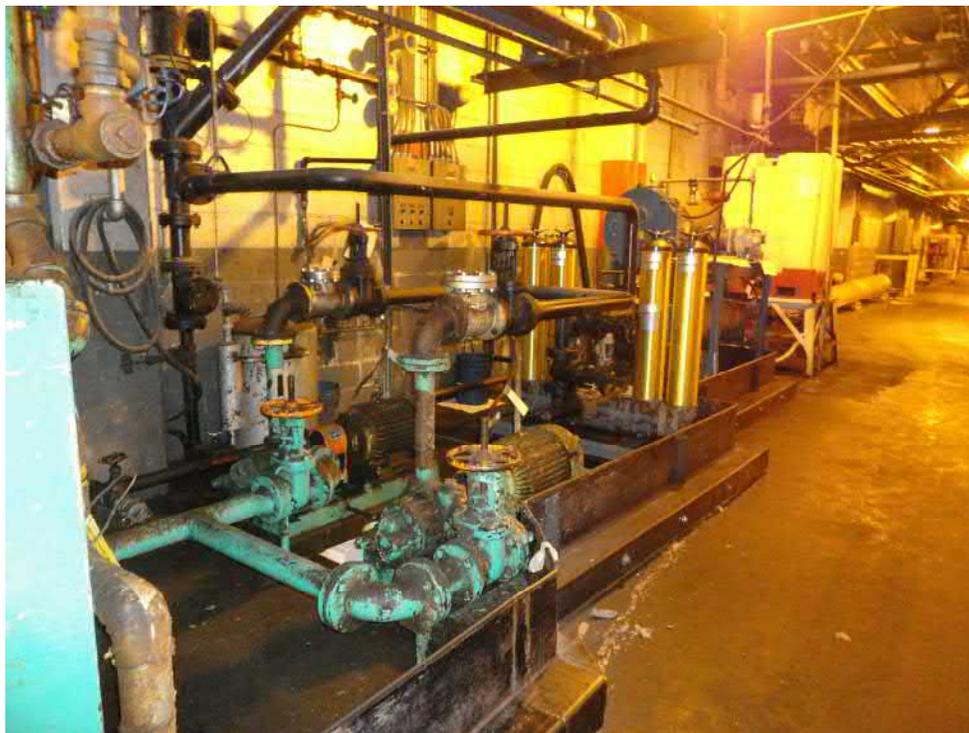
The next major components in the system are the **oil filters**. In the next picture there is an assembly of four filters. These four filters are the ones that filter the oil before it goes back to the bearings and gears on the machine. The oil flows through two of them at any given time while the other two are in standby or are being serviced.

The lube technicians told us they get about a month out of a set of filters unless the oil has a lot of water in it. **It should be possible to increase this if the system had the capacity to generate more oil pressure and there was less water getting into the system.**

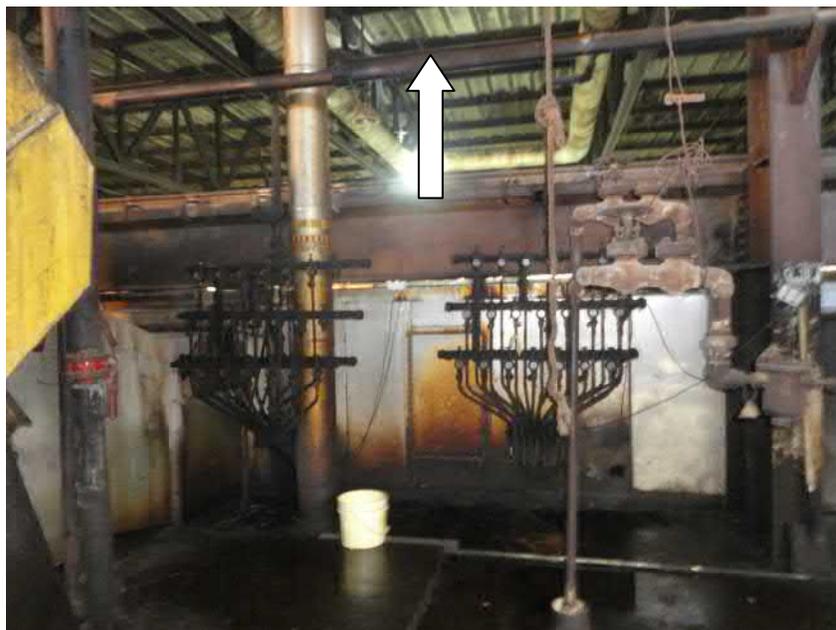
In three places carbon steel lines branch off the drive side header and cross the machine over the hood to supply oil to the tending side of the machine. The sight glasses for the front side lube points are located above the hood on the tending side and are accessed from a cat walk that runs the length of the machine. See the second picture on the next page.

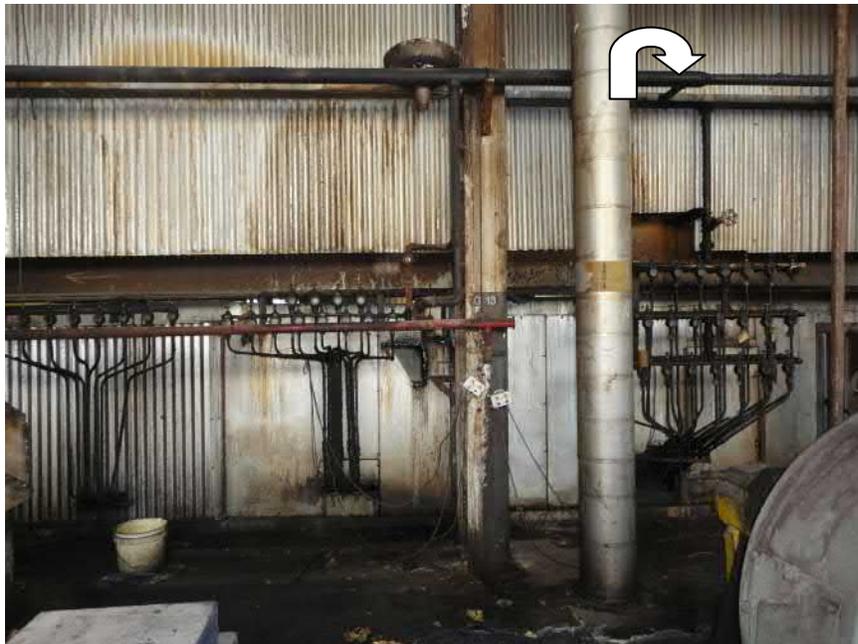
The supply headers are large enough for the system today but the system should be run at a higher pressure in the future. This will be explained further in the report covering the individual lines between each sight glass and lube point. New systems today are designed using 304 or 316 pipe materials. Connections to the groups of meters should come out the top of the supply headers rather than the bottom or side as they do now. See the next picture. The arrow shows the connection of the supply to the sight glasses comes out the side of the main header pipe. Any heavy particles moving with the oil inside this header have more chance to go directly down and into the sight glasses and perhaps the bearing if the sight glass does not plug. New systems are designed with the oil meter feed line connected to the top of the supply headers and pipes are sized to avoid large pressure differentials in the piping to insure that every group of sight glasses has approximately the same inlet pressure.

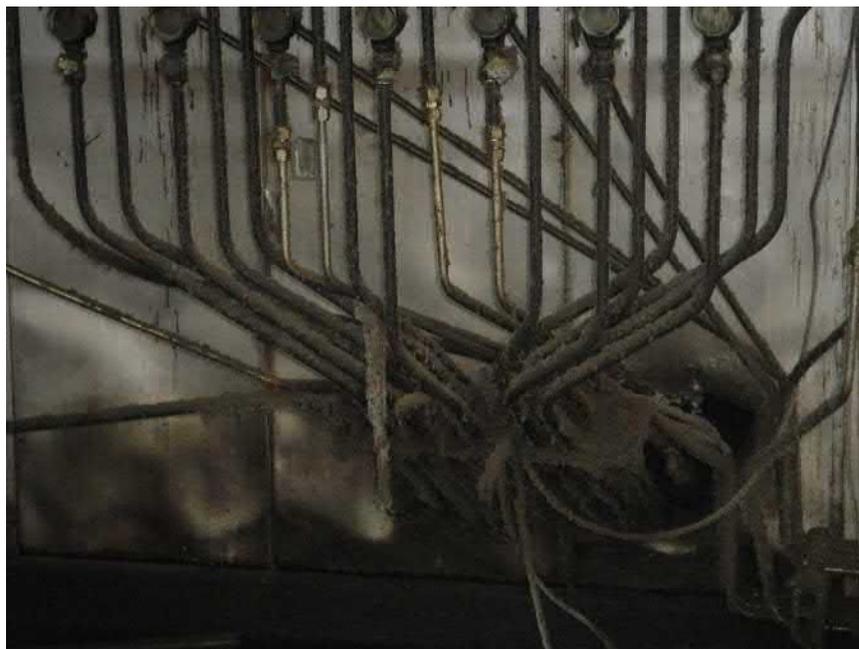
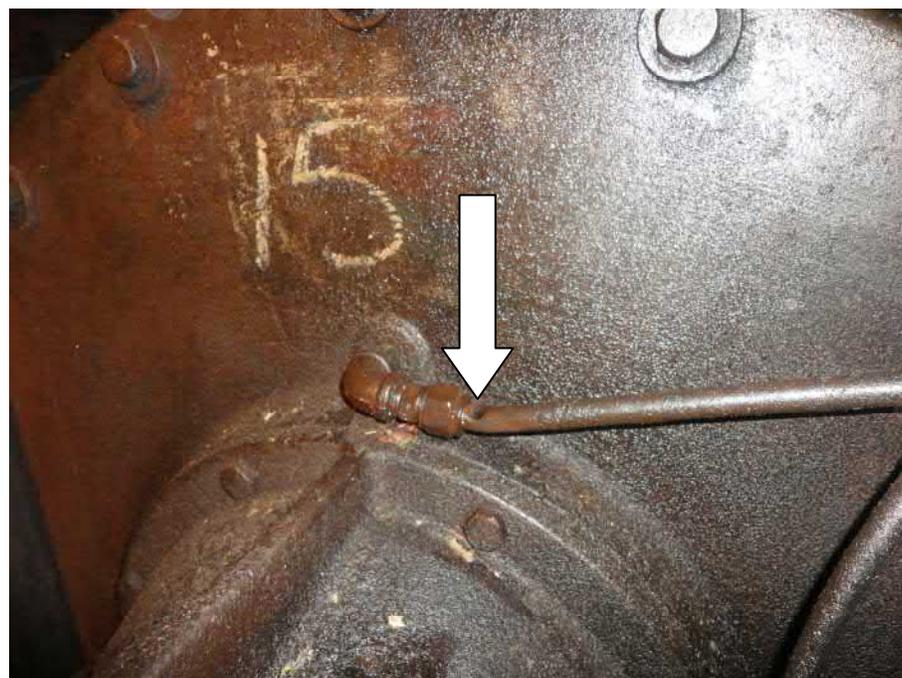
After the oil moves through the meters it enters the **smaller oil supply lines** which carry the oil to each lubrication point. There are approximately 538 active lubrications points, each with a supply tube and several discontinued tubes that are still in the machine. The majority of the tubes are 5/8" steel tubes with a few 1/2" stainless steel tubes. It appears that the stainless steel was used when the old steel tubes have been replaced. In some cases the old tubes have been crimped or damaged. See the next two pictures. We believe that the steel tubing is the original and is the source of some of the oil leaks on this machine.

Cracking and pitting of the steel tube is likely to form in areas closest to the wet end of the machine and in places where wash up water and chemicals can lie in the tube bundles. The problem will be worse if the tubes are not well supported and can vibrate. Leaks in the tubes are often very difficult to find and in some cases almost impossible to fix because of the way the tubes are clamped in bundles.

After the mill has selected the locations for new oil flowmeters they should start a program to replace the carbon steel tubes with stainless and only the best grades of stainless should be used in the first dryer section which will be the closest to the wet end.

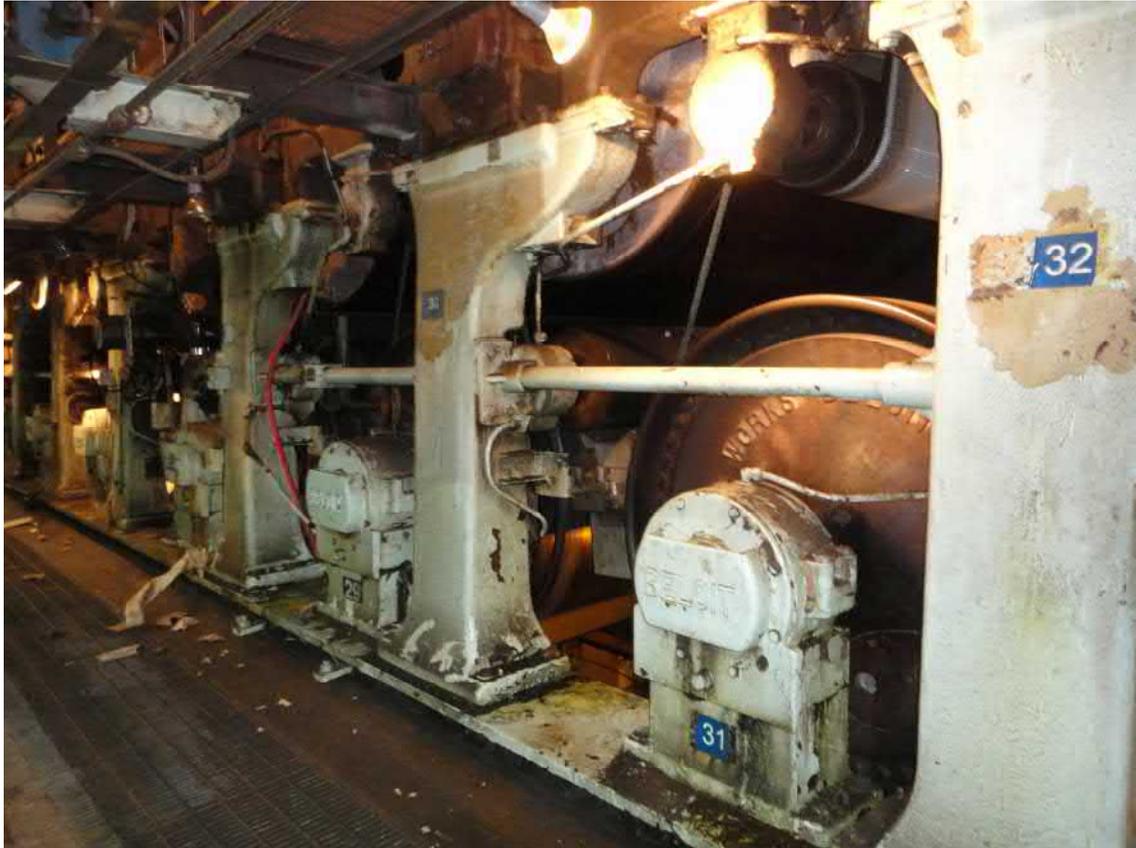
After the oil travels through the supply tubes it reaches the different bearings and gears. Please see the following picture of the tending side of the machine. This pictures shows **dryer bearings and felt roll bearings on the tending side of the machine.**

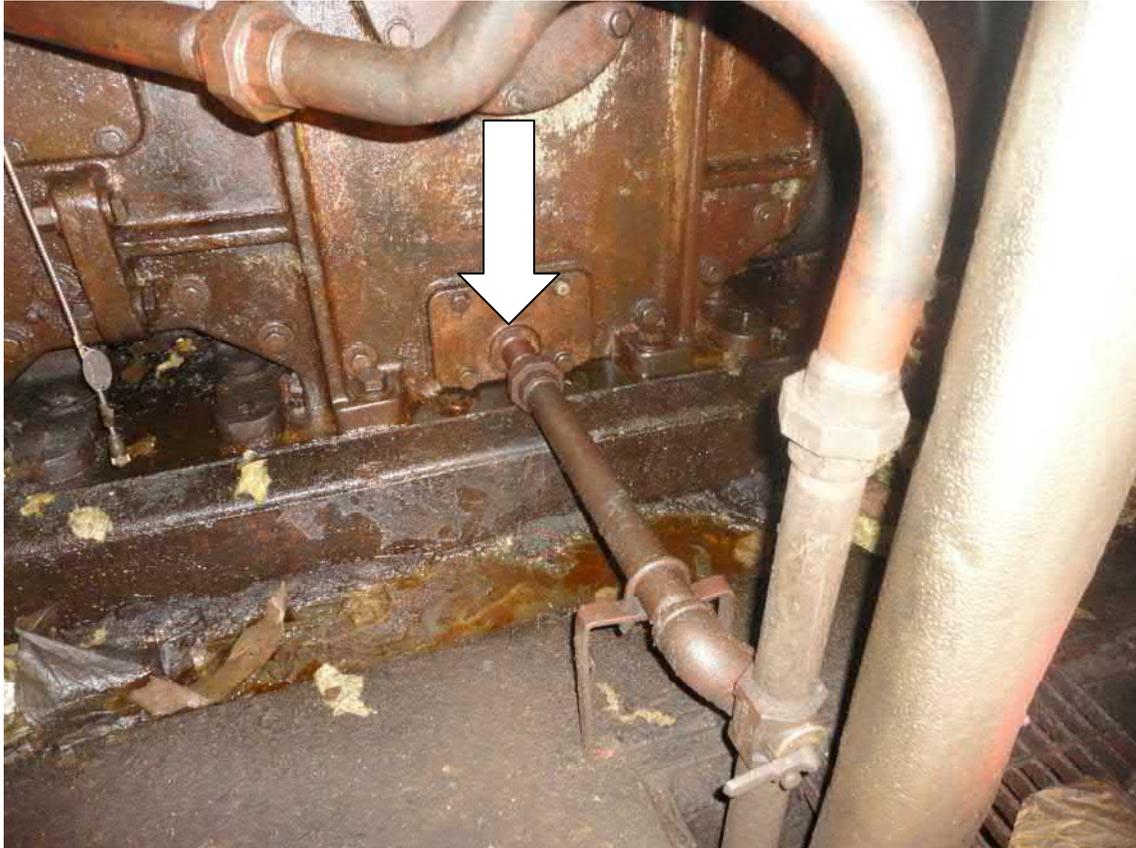
The gear case collects most of the oil on the drive side. Dryer bearings, intermediate gear bearings, gear nip lubrication and some of the felt rolls drain into the gear cases. The drains from the drive side gear case are 1.5". Most drains are connected from the inside of the case but a few drain from the outside. See the next picture. Those on the inside use an identical drain port but it is on the back side of the case, closer to the dryer cylinders.

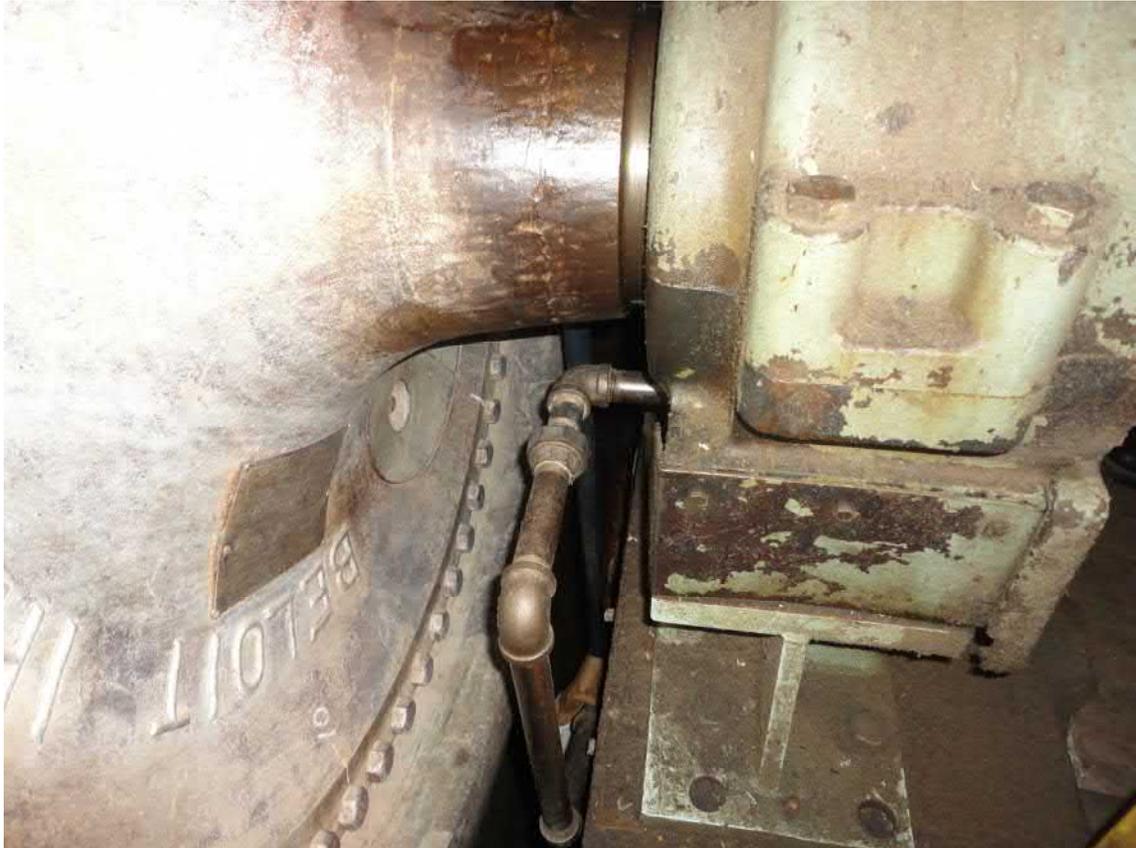
The next two pictures are of typical front side dryer bearing housing with a 1" drain line from the inner side of the housing. These bearings should receive 4.0 pints of oil per minute.

The picture above shows a typical front side dryer bearings housing with 1" pipe connected to the inner drain port of the bearing housing. Note in the next picture there is an unused drain port in the outside of the housing. The next picture is typical of all front side dryer bearings where the inner drain port has been used. See the next picture. The arrow is pointing to the unused port in the bearing.

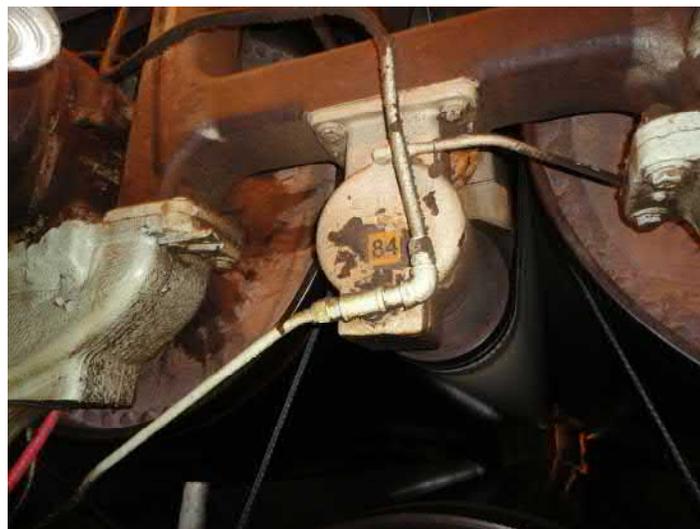
The felt roll bearing in the next picture will not drain the proper amount of oil because another bearing above it is draining into it's drain. This can case oil to back up in the lower bearing.

The felt roll bearings should have an oil flow of 1 pint per minute and to achieve that flow need at least a $\frac{3}{4}$ " drain port. As well as lines that are too small we found some with hoses that had low spots creating sump pockets and some with street elbows at the bearing. Hoses and street elbows typically have smaller internal diameters than pipe and should be avoided unless properly thought out. The next picture shows one case where red rubber hose has been used as a temporary fix for front side dryer bearing drains. This should be replaced when possible.

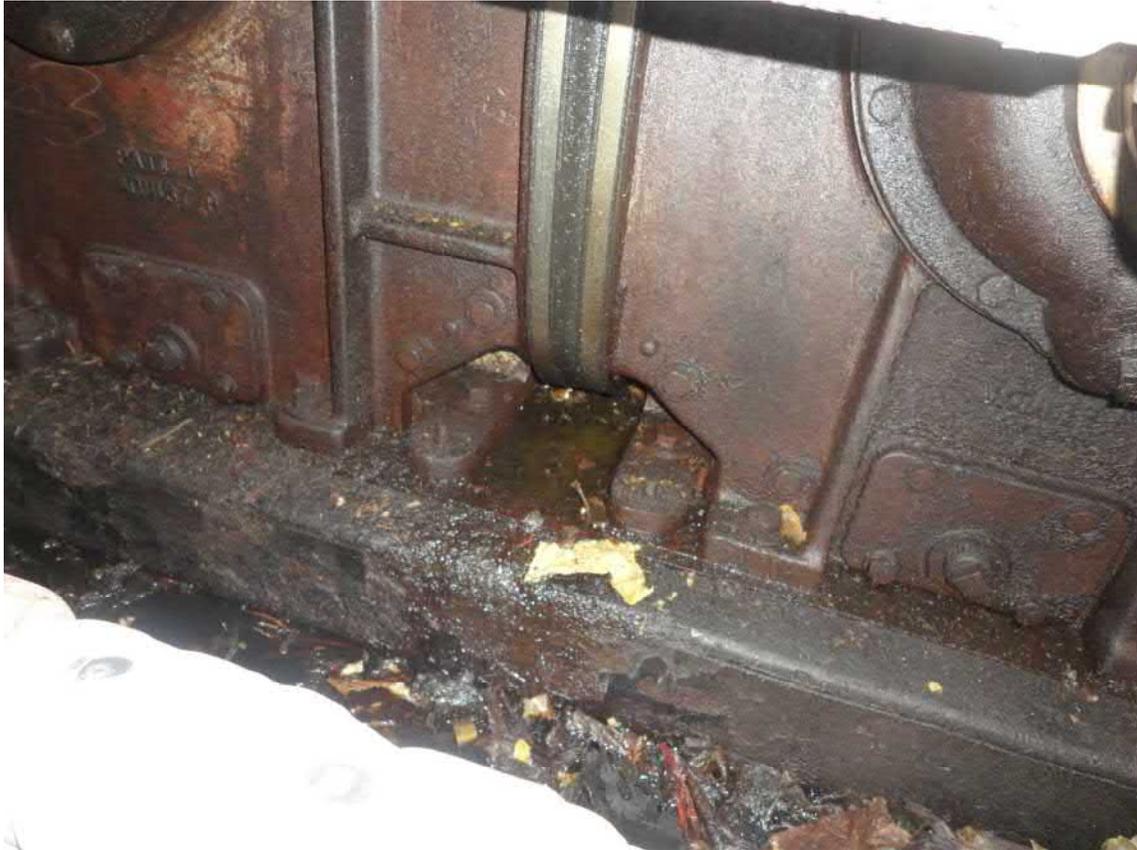
The drive side gear cases leak and like many machines of this style and age, the leaks are very difficult to find or reach to make a repair.

This style of machine with sections of gear cases bolted together and having many bolted covers, combined with the wear and tear of many years of running 24 hours a day often leak.

A systematic overhaul of the gear case joints and covers by installing new gaskets or gasket material where possible should be started. New bolts properly torqued and re-torqued when the machine has run awhile will be required. Loctite or similar products should be used to keep the bolts from loosening. In most cases this is an ongoing process that people are assigned to each shutdown. The payback will be fewer oil leaks, improved safety and environmental issues but also the people involved in this type of work, if properly motivated will pick up other potential problems before they become serious.

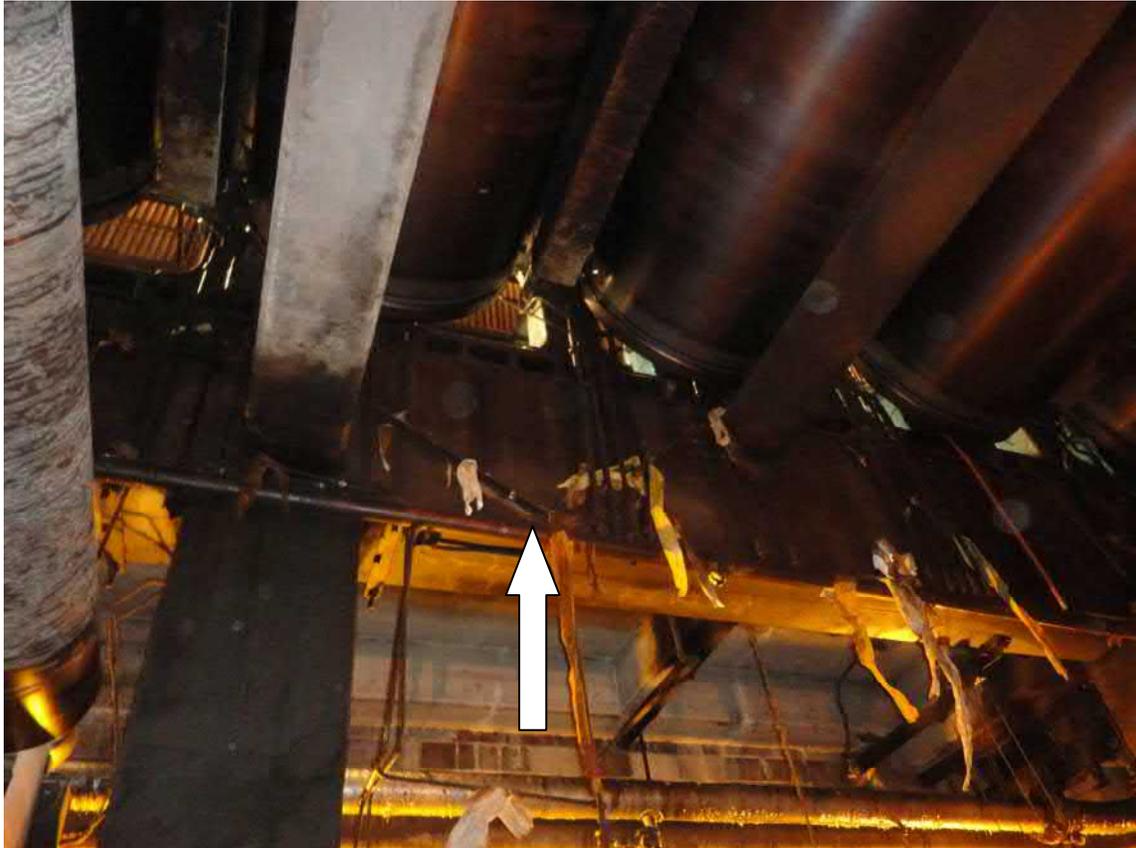
When the oil exits the bearings and gear cases it drains through the smaller pipes, tubes and hoses of various size that we have already discussed. These pipes, tubes, and hoses direct the oil into larger pipes that make up the **main drain header system**. Together the smaller diameter items and the larger main drain pipes make up the total oil drain system. Most of the main drain pipes are carbon steel. We were not able to learn much about their internal condition. It would not be unusual to find that they are partially blocked with corrosion and sludge after all these years. The arrow in the next picture is pointing to some of the larger of the drain pipes under the paper machine.

With the exception of the forth and fifth dryer sections the main drains on this machine are generally large enough for the oil flows used today. However, they will not be large enough for the flows this machine should have. A new system of drains should be engineered and installed with proper venting before oil flows are fully increased to all lube points. The new system should be built of stainless steel, using welded

connections as much as possible. It should have a minimum of screwed fittings. The existing system will leak worse if the flow rates are increased before improvements are made to the drains and gear cases.

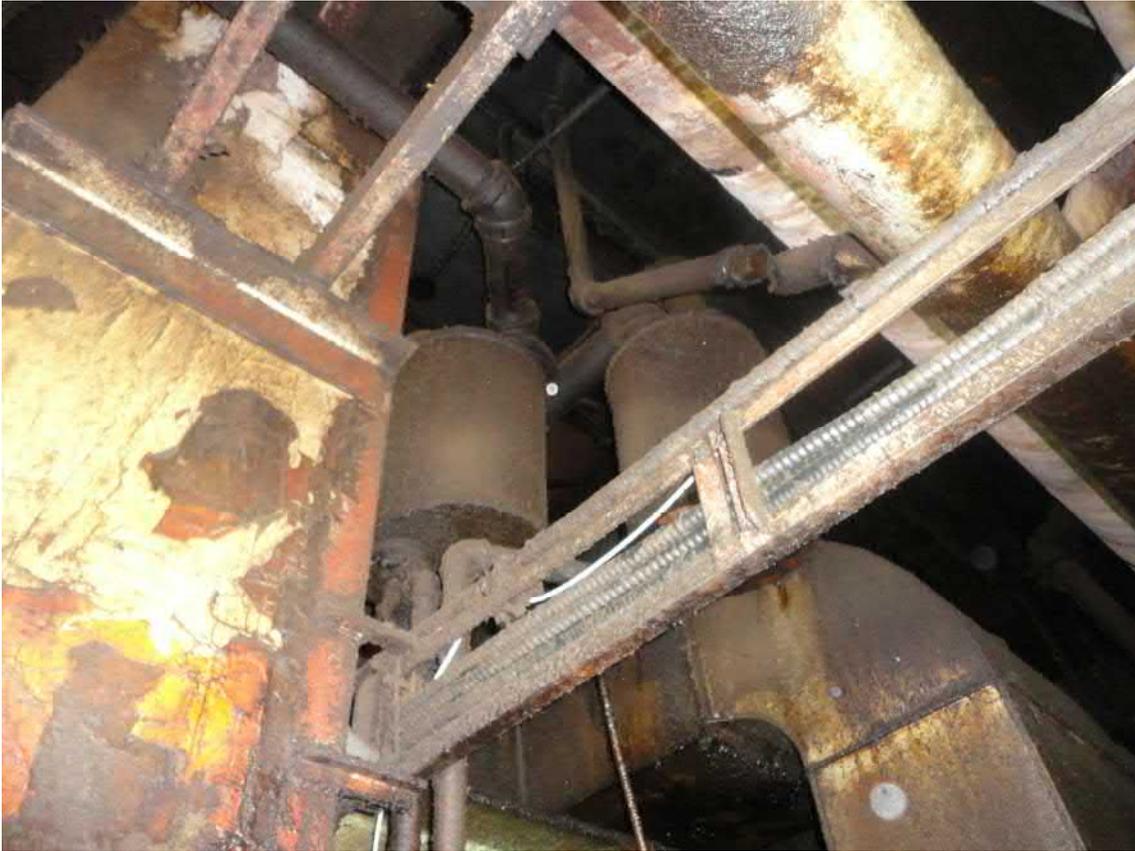
The existing main drain system has four Beloit style water collection pots in it. Two are on the tending side and two on the drive side. See the next two pictures. The first picture shows the two on the tending side and the second picture shows the two on the drive side. These should be checked and the drained off every day. These can be used as an early warning of water problems.

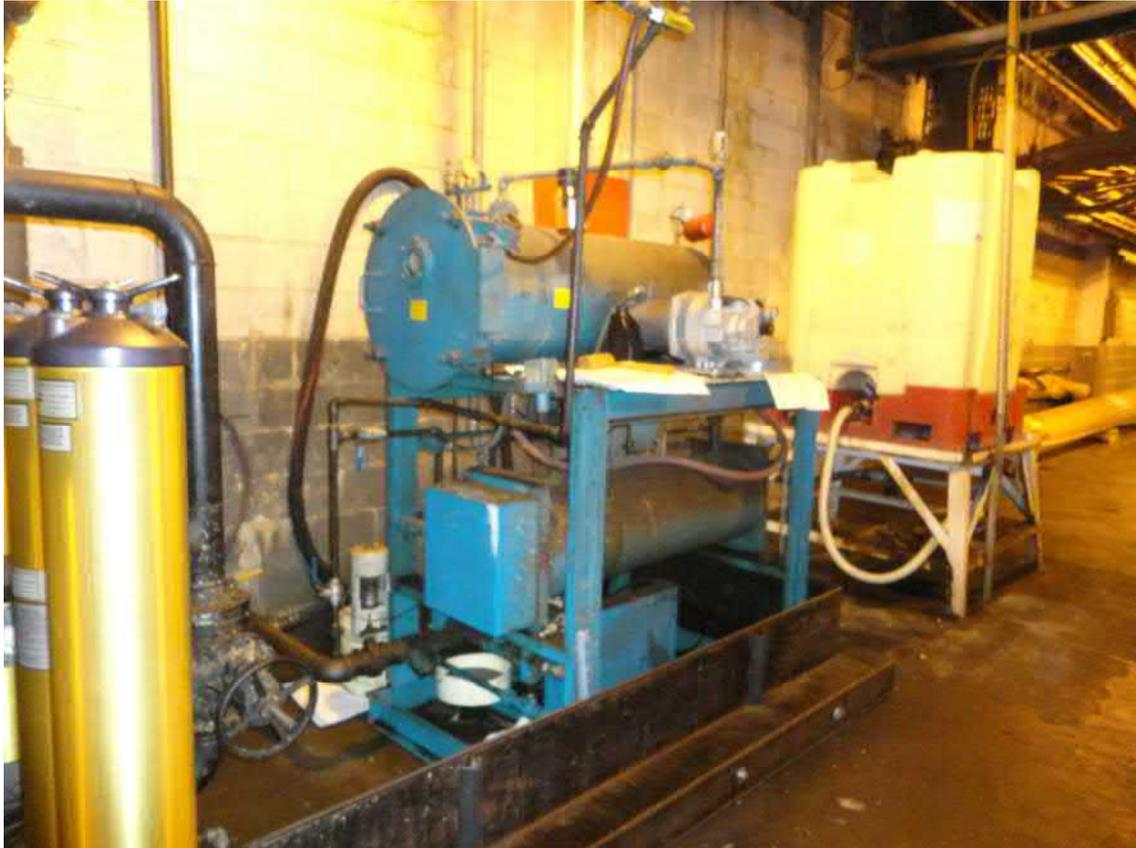
Water contamination of the oil is a major factor in bearing failures on most paper machines. Presently the oil reservoir in this system is too small to be of much use in water removal. The oil is kept so agitated inside that little water has a chance to settle out. We are told and also observed that there is no way to drain free water off the bottom of this reservoir. Due to the way oil enters and is pumped back out we know not much water will settle out in the existing reservoir. This makes the water traps and the one vacuum dehydrator attached to the system very important. See the next picture of the vacuum dehydrator. This unit should be well maintained and kept

running as much as possible. The unit in this picture is connected to the main lube unit on both PM 14 and PM 13. Each machine should have a dedicated dehydrator.

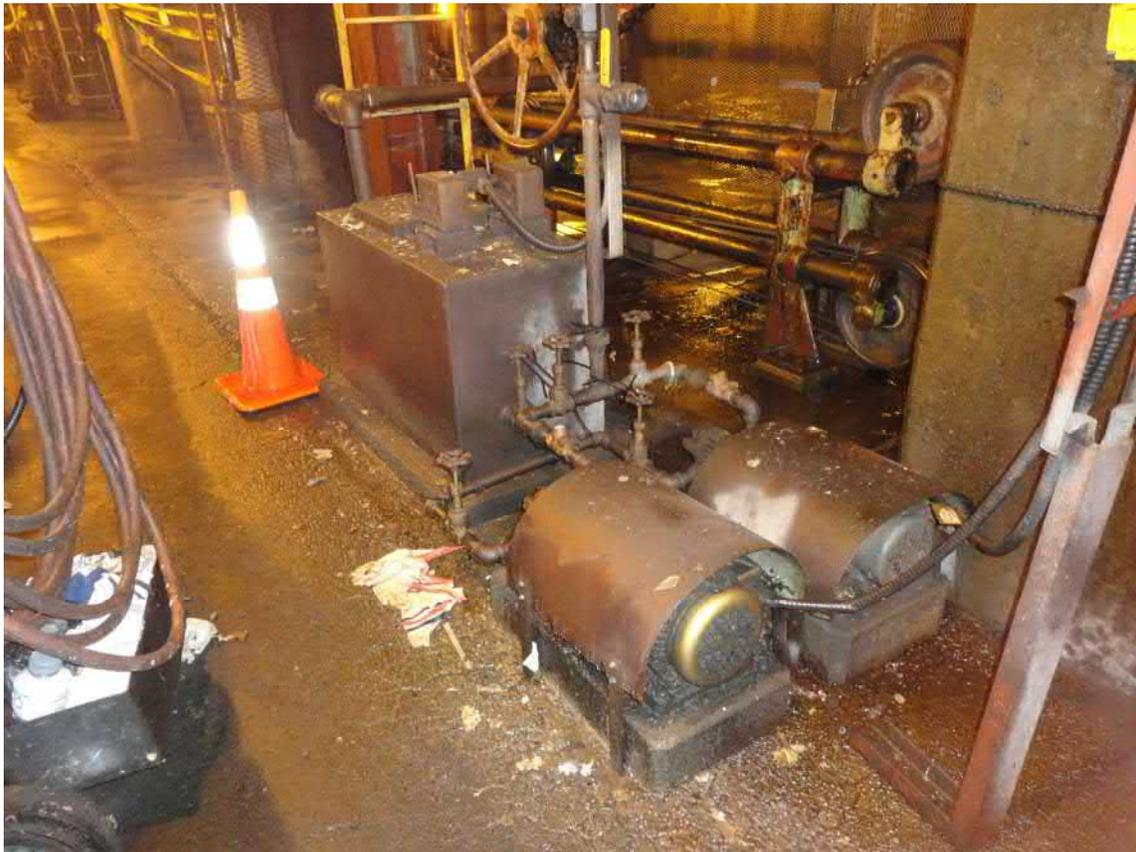
sump systems. Two for each dryer section with one being installed on each side of the machine in that one dryer sections. See a typical sump reservoir and it's oil pumps in the next picture.

Oil collects in the sump's reservoir until the oil level reaches a point sufficient to trigger a level switch. This starts one of the pumps and provided that pump works well the oil is pumped out and into the larger main drain system above.

in many cases. The drain system for the basement felts rolls needs to be included in the re-design of the oil drain system. The basement felt roll bearings are a common source of oil leaks in this type of machine and special attention must be given to their drain system. The sumps need additional attention like cleaning and normal PM inspections to see that pumps and back-up pumps start and run as they should.

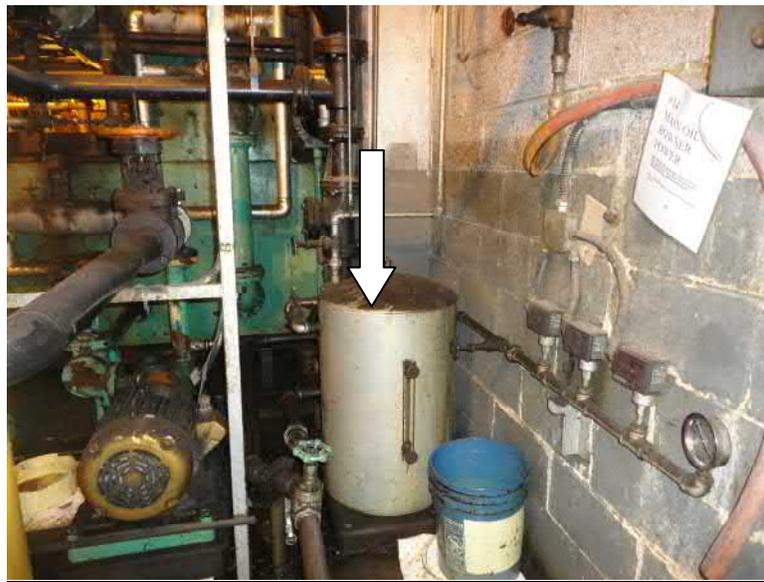
The picture below shows some of the old electrical switches in the system. The arrow is pointing to an air over oil type accumulator that Beloit put in many of their low pressure systems built in the 1950's. This device and associated switches should be replaced with a modern control pressure control and alarm system as part of the overall update of the system if it continues to be used to lubricate this paper machine.

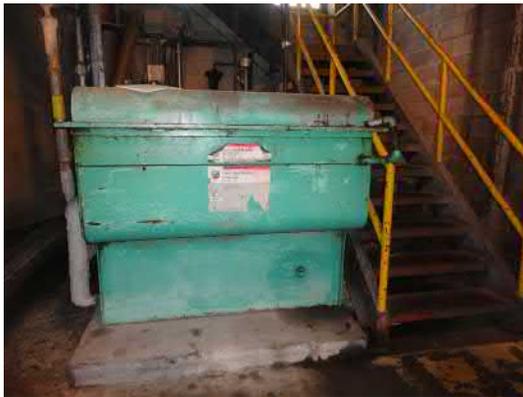
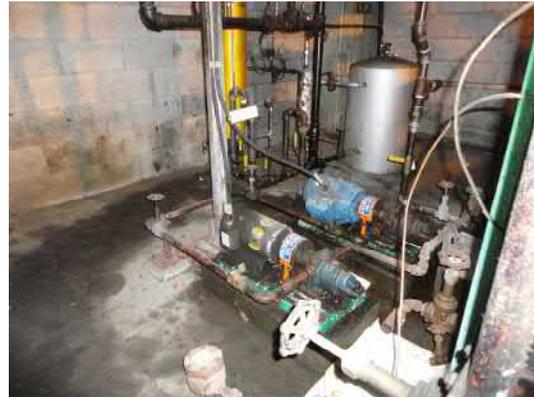
This systems pumps and motors can supply approximately 11.5 gallons of oil per minute at 100 psi. ISO 220 oil is used in this system.

This flow is marginal if all bearings were to get the SKF recommended flows. The pumps in this system are designed so they could be turned at 3600 RPM is necessary. It might require a 7 HP motor at that speed but the pumps on this system can supply more oil if we want them to.
