Lubrication System Audit
Report Paper Machine *

SKF

SKF Lubrication Services Division

August ****

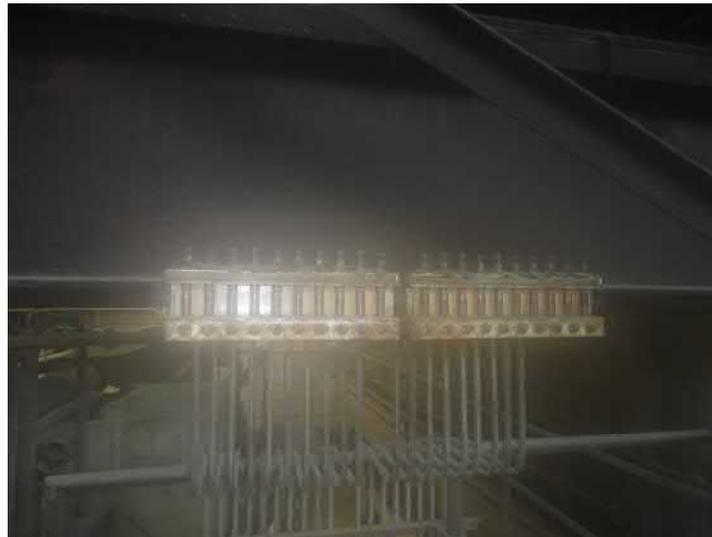
The oil flowmeters on the tending side of the calendar stacks and After Dryers are Beloit C-Shurs just like those in the five main dryer sections and have all the same problems. The lube points on the drive side of this section of the machine are serviced by Safematic (Now SKF) model SF flowmeters. See the next two pictures. The first picture below shows two banks of 10 meters, each meter being the size SF10. These are an excellent meter for paper machines when used properly. One problem we found was that all 20 meters (only 19 were in use) were set for approximately the same flow rates. That means that a calendar stack roll that needs approximately 1.5 pints per minute is getting the same flow as a bearing on the King, Queen or dryer cans. **This is not correct and the flows should be adjusted according to the needs of each bearing or gear.**

These meters have been installed with stainless steel tube connecting them to the lube points. This is the way we would like to see the whole machine done. However, as long as this machine lube system runs at low oil pressures the size and length of those tubes is very important. Tube too small or too long will take require more pressure than the system might be able to provide.

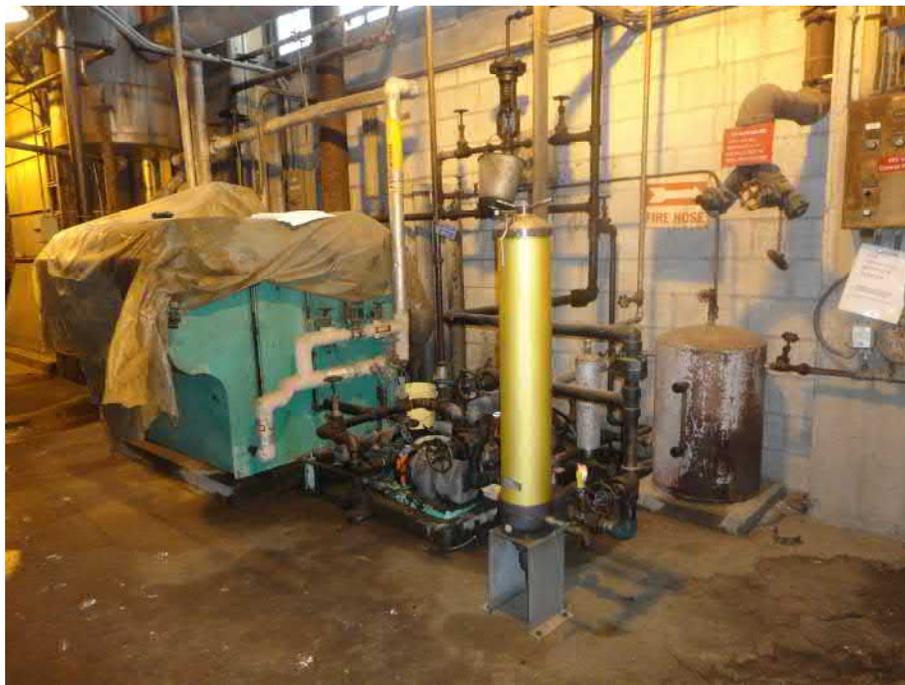
The differential drive lube unit is very much the same as the Calendar and After Dryer Lube System with the exception that the pumps on the differential drive lube unit are Roper 2F 20 Type 27 lube pumps. ISO 220 oil is also used in this system. These pumps are driven by 2 HP motors turning 1725 rpm. These pumps will supply approximately 22 gallons of oil per minute when turning 1725 RPM. This flow could be doubled if the pumps were turned at 3600 RPM.

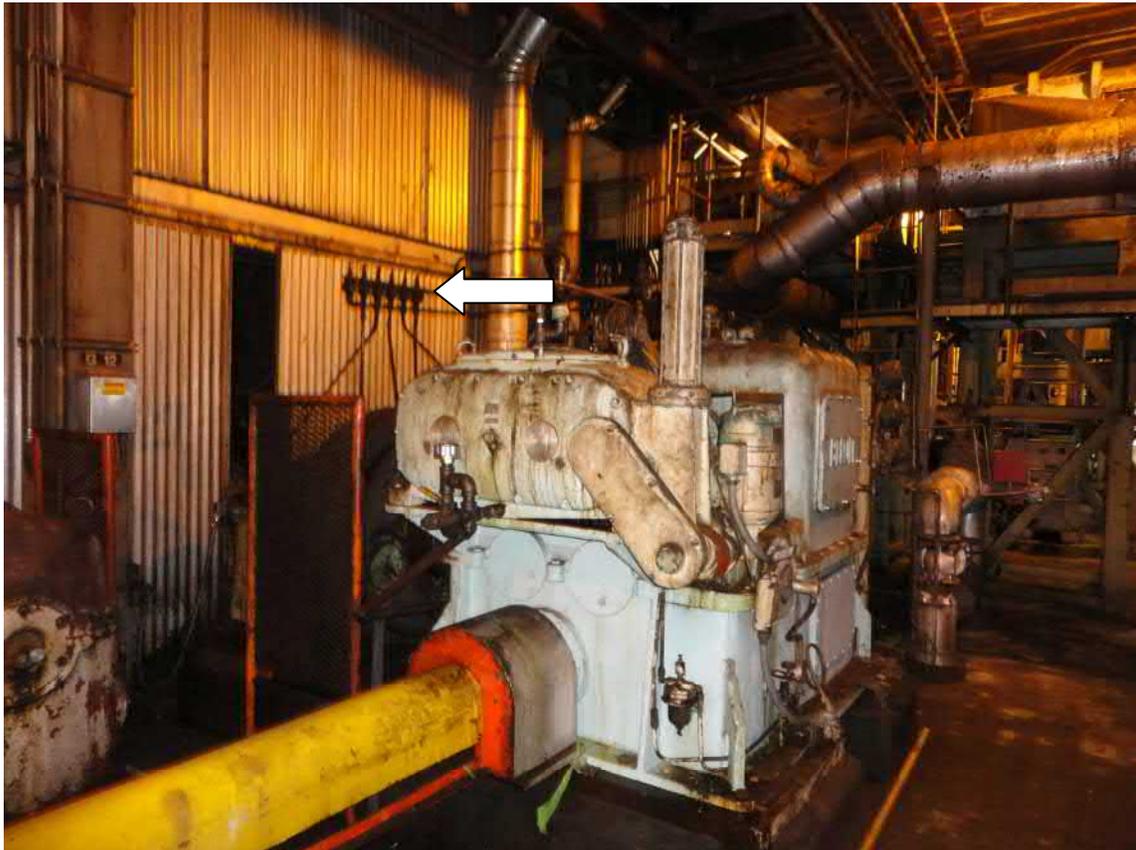
There are approximately 60 lubrication points this system is supplying oil to. Each point is monitored with a Beloit C-Shur. See the next picture. The arrow is pointing to a group of the C-Shurs.

The after dryers and the differential drive system do not have the immediate problems as the five main dryer sections but they also use the Beloit C-Shurs for most of their lube points. These C-Shurs have the same problems as those in the main dryer sections. A longer term plan should be to replace those as well.
